Valmont™ Bridge Systems Case Study Mercer County

Henry Road Bridge Superstructure Replacement Project

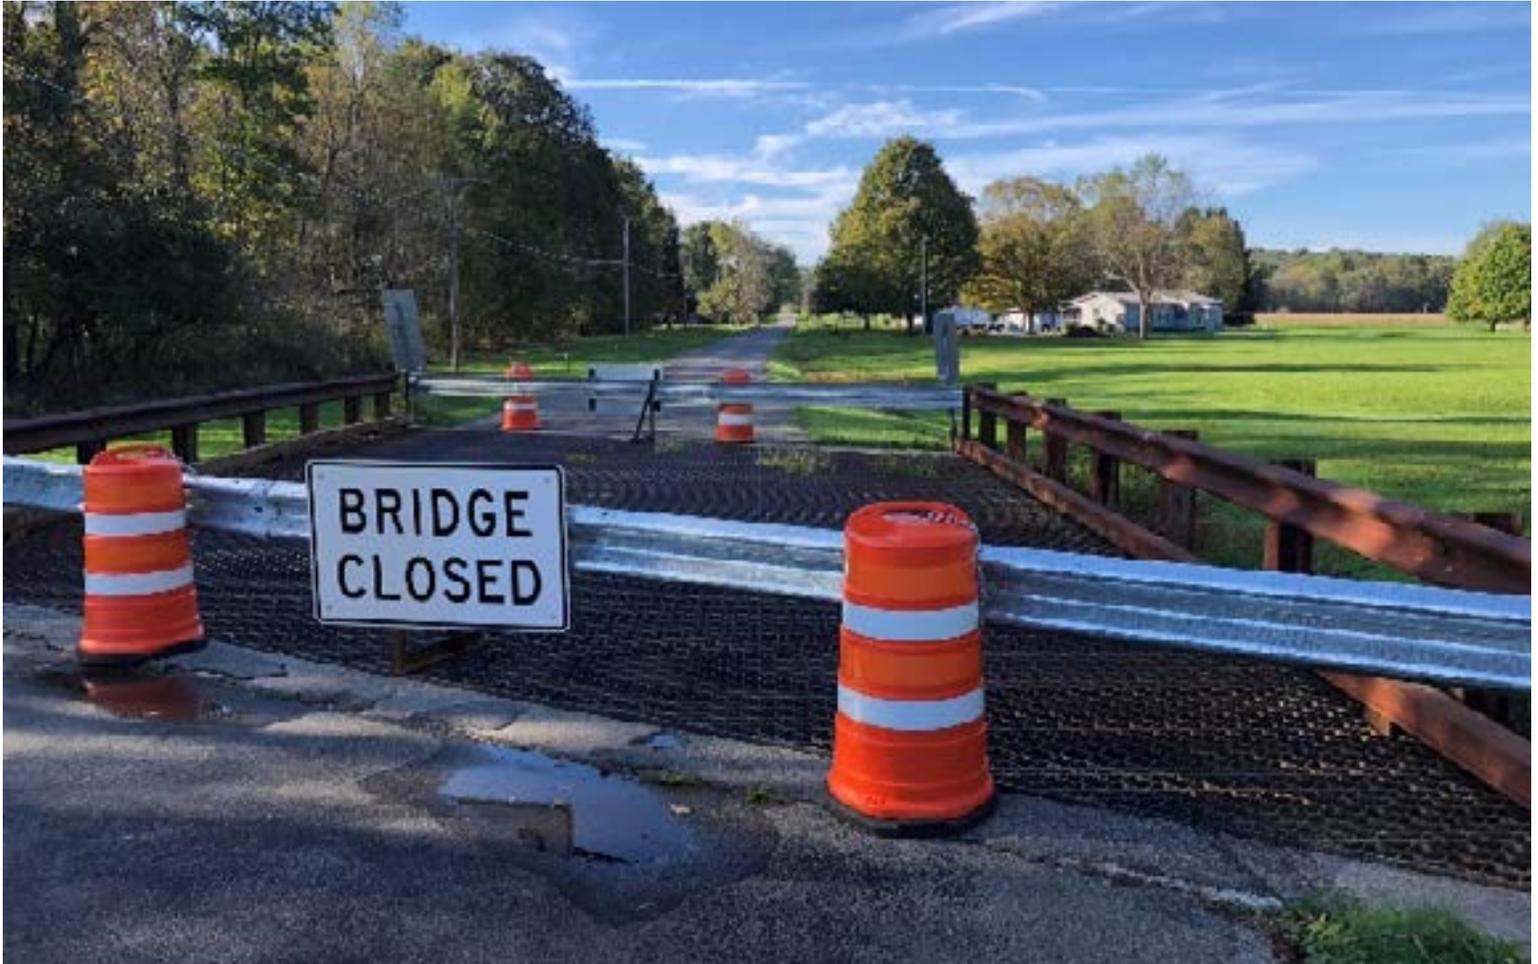
Closed Henry Road Bridge in Mercer County, MI

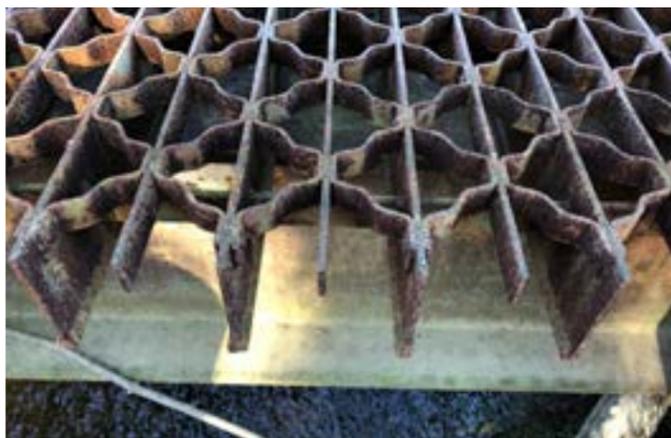
Deteriorated Existing Steel Grating Bridge Deck

In June of 2018, Brad Elder, Mercer County Bridge Department Engineer, traveled to the International Bridge Conference (IBC) in Orlando, FL hoping to find a solution for replacing his 34 structurally deficient bridge superstructures. Consisting of heavily deteriorated steel beams and an open steel grating bridge deck, these bridges were in such poor condition that many of them had been closed to traffic.

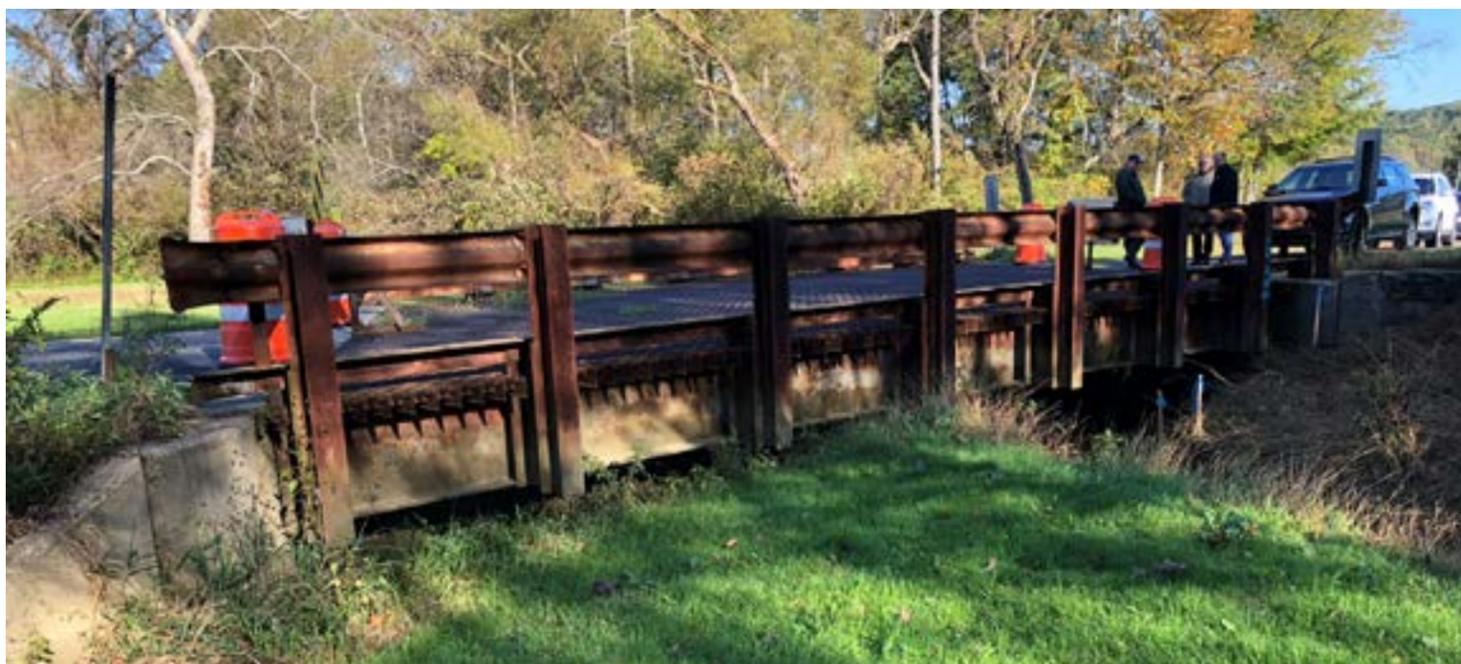
Closed Deteriorated Existing Henry Road Bridge.

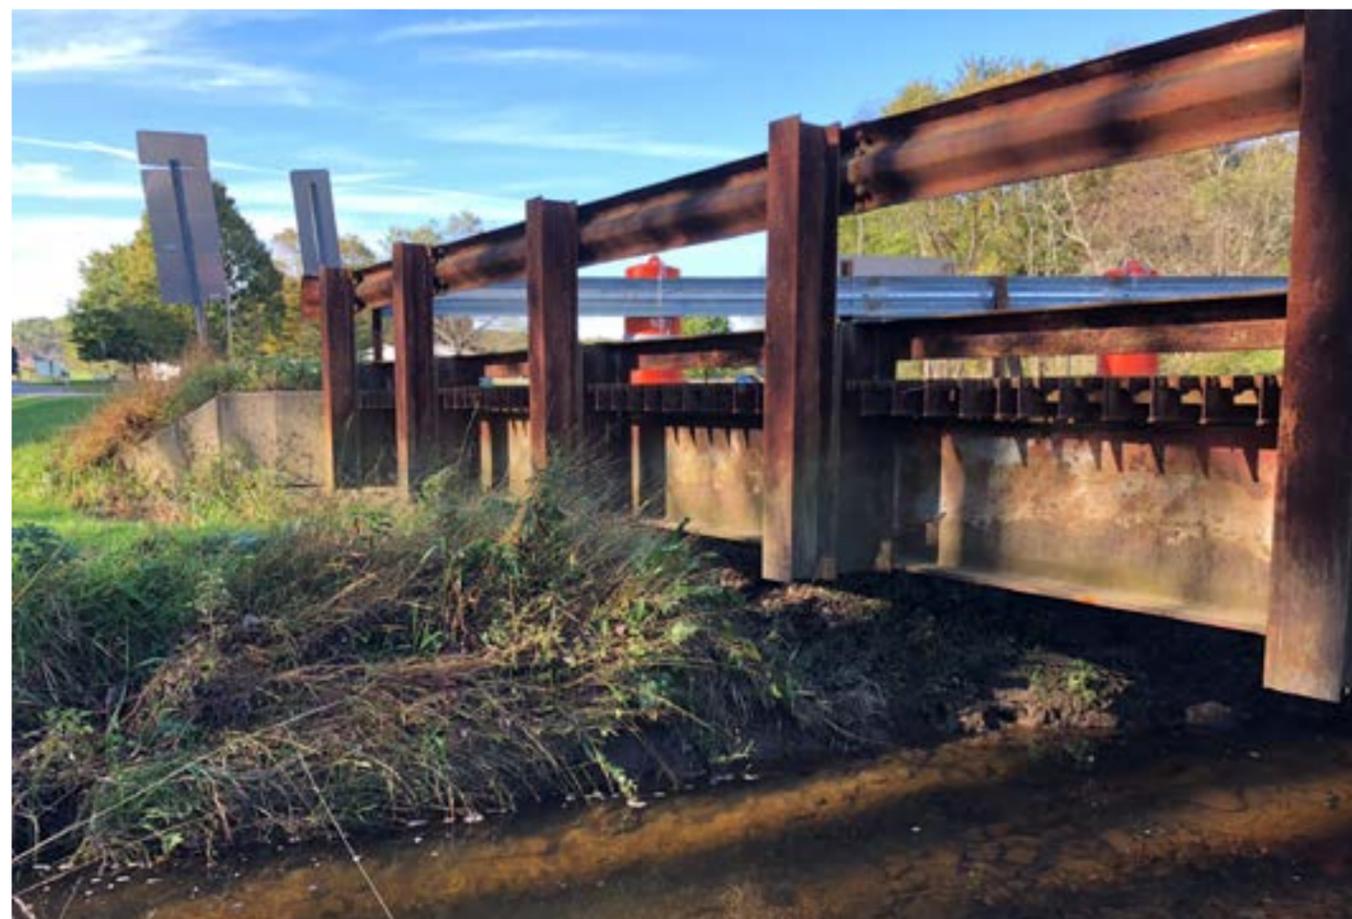
Deteriorated Existing Steel Grating Guardrail Posts

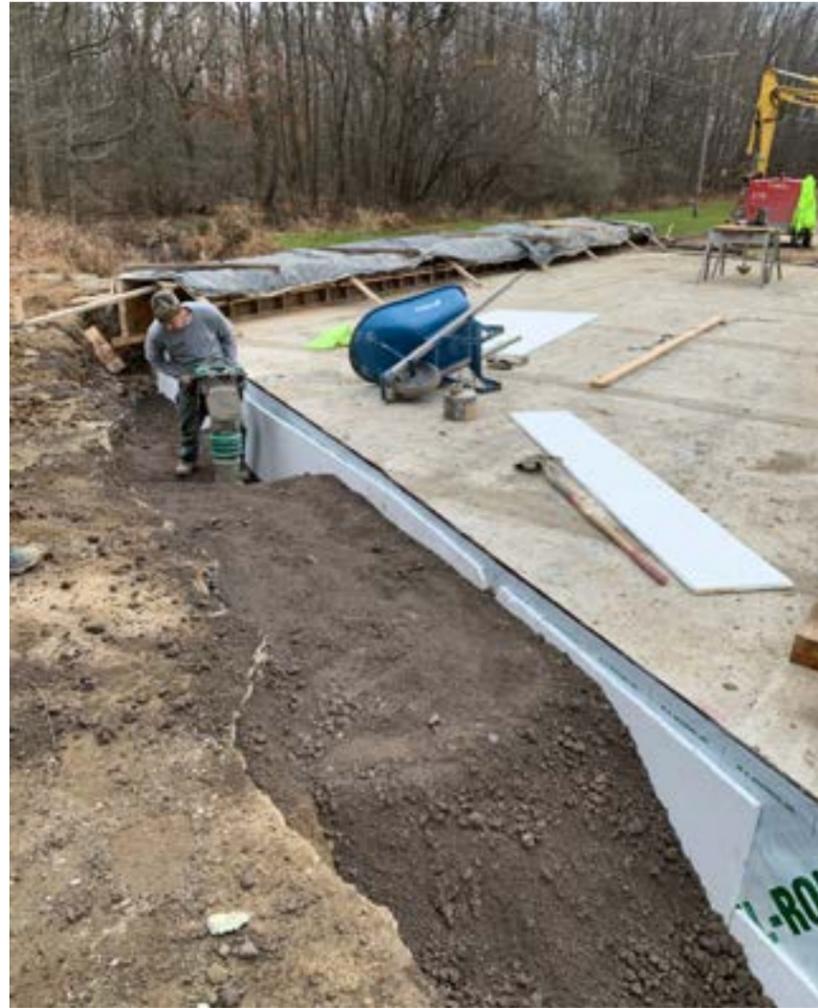
High Strength Concrete Deck Joints and Casting Curb Under Guiderail

Over the next week, the shear stud pockets in the precast concrete deck panels and the transverse deck joints between the precast concrete deck panels were filled with high strength polymer concrete, the concrete brush blocks beneath the steel guide rails were cast with concrete and the steel guide rail was installed atop the concrete

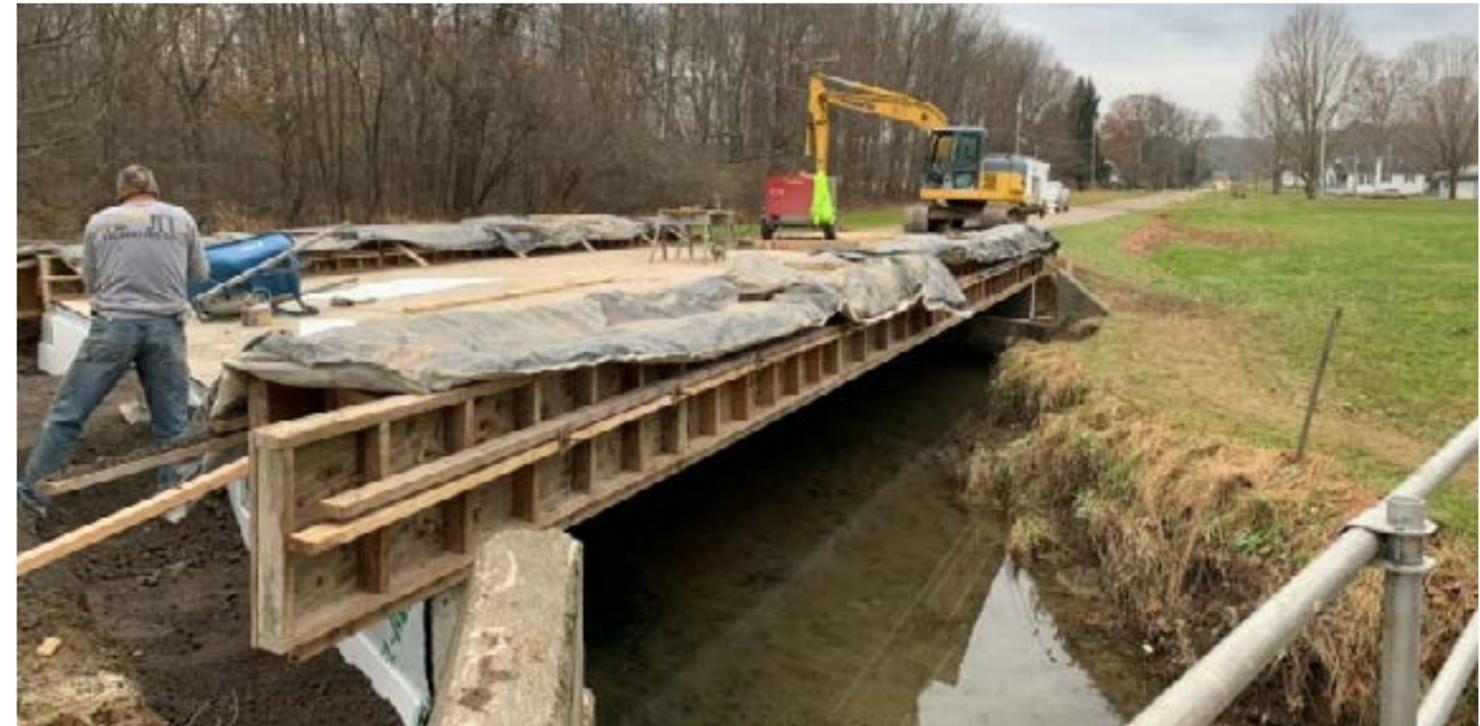
High Strength Concrete Deck Joints and Casting Curb Under Guiderail

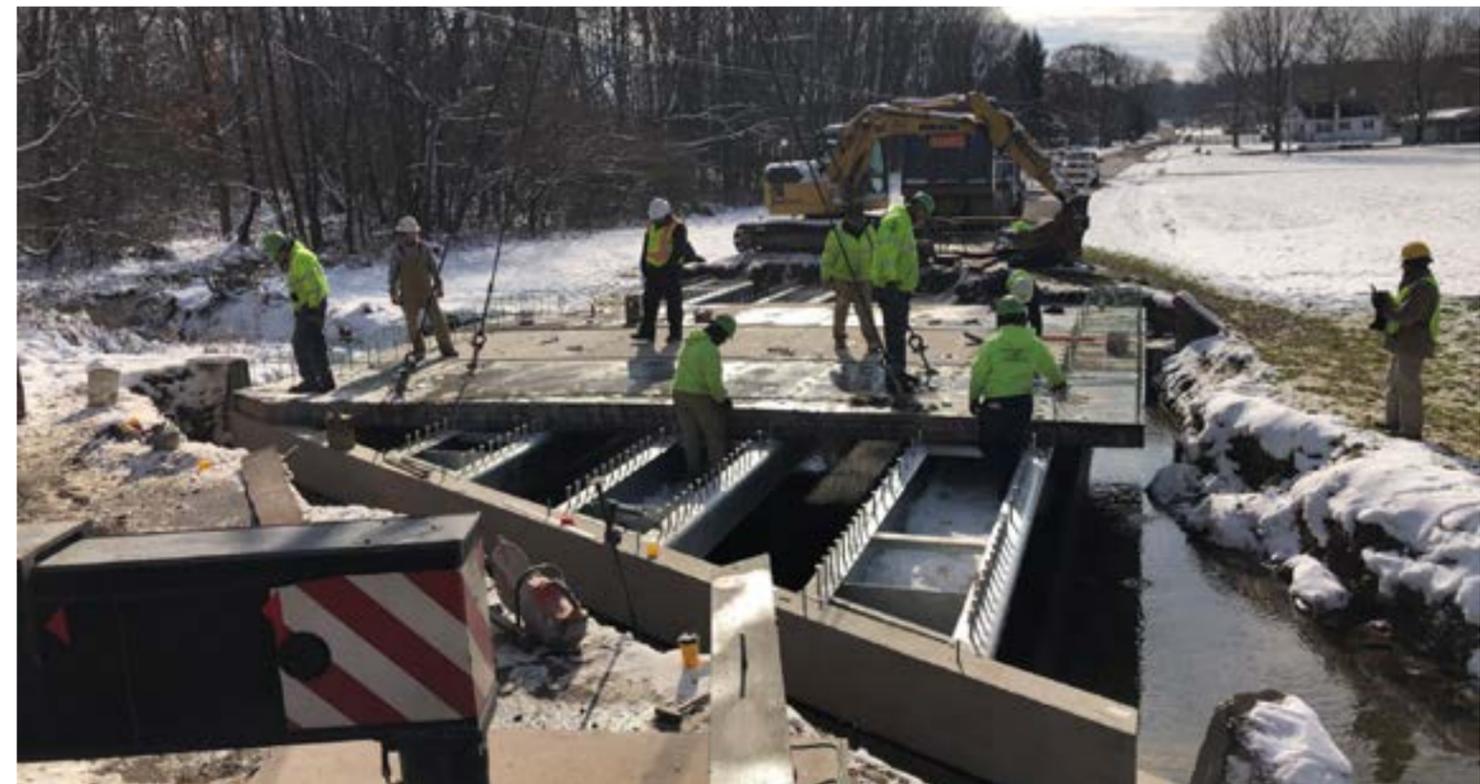
Installation of Precast Deck Panels on PBFTGs

By Thursday, November 12th, the existing deteriorated superstructure was removed. The galvanized press-brake-formed steel tub girders were delivered to the construction site and installed on the existing concrete abutments. The following Tuesday, all 8 precast deck panels were delivered to the project site and installed on the new press-brake-formed steel tub girders the same day.

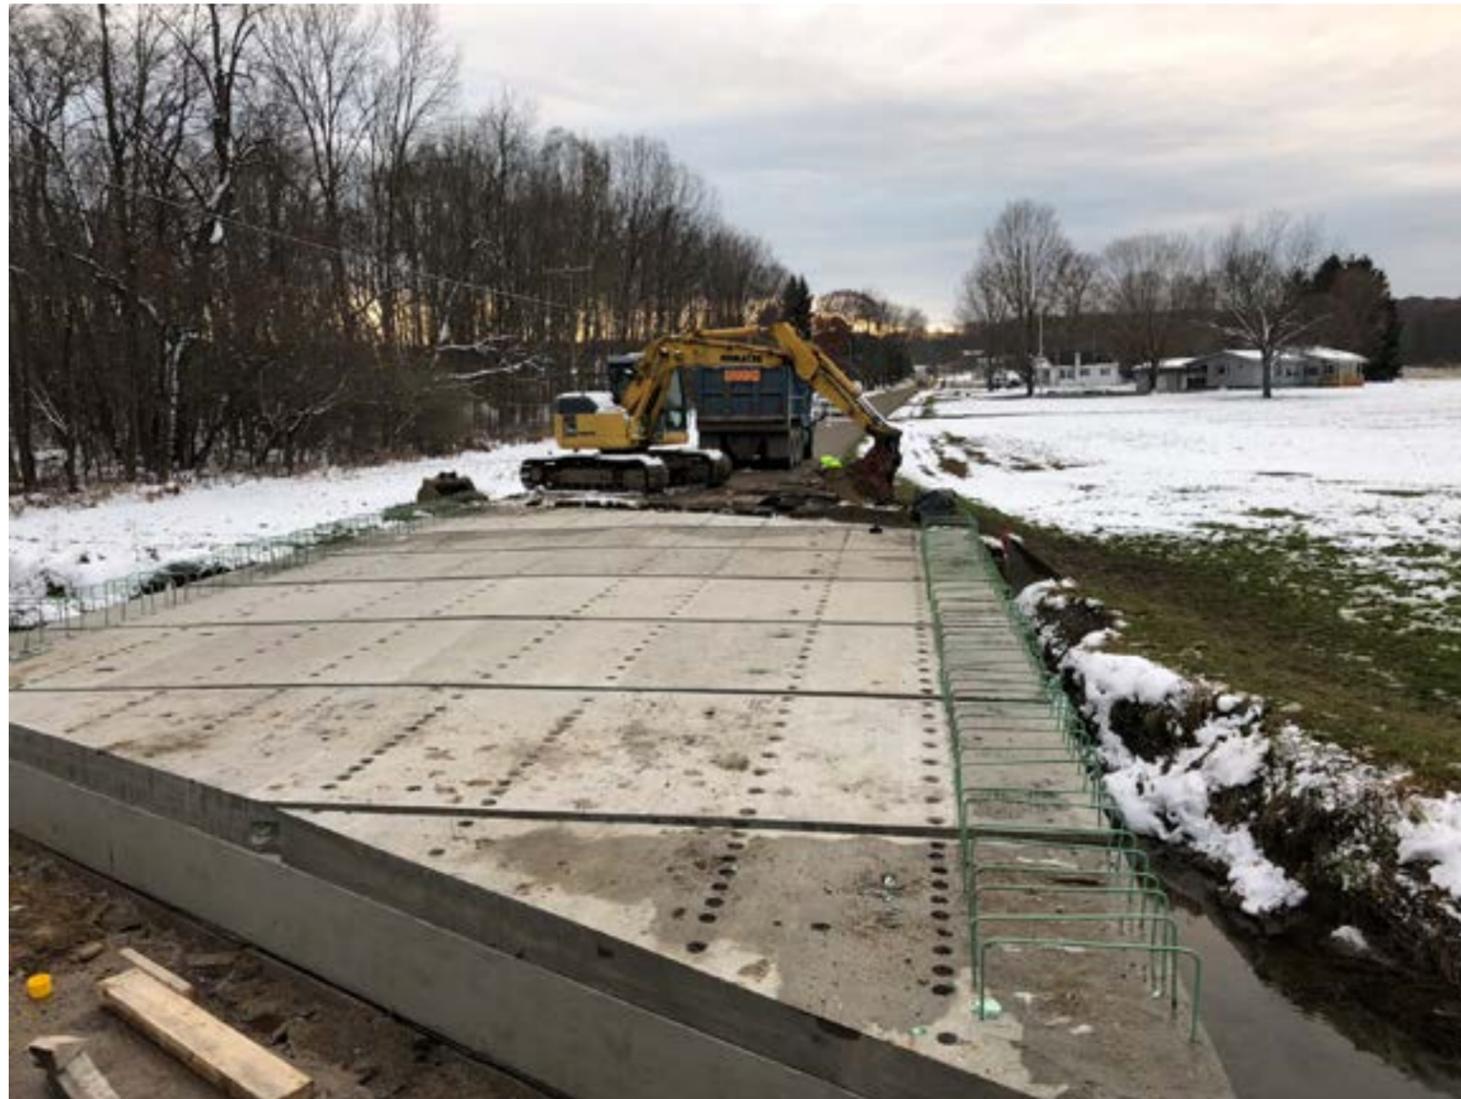
Installation of Precast Deck Panels

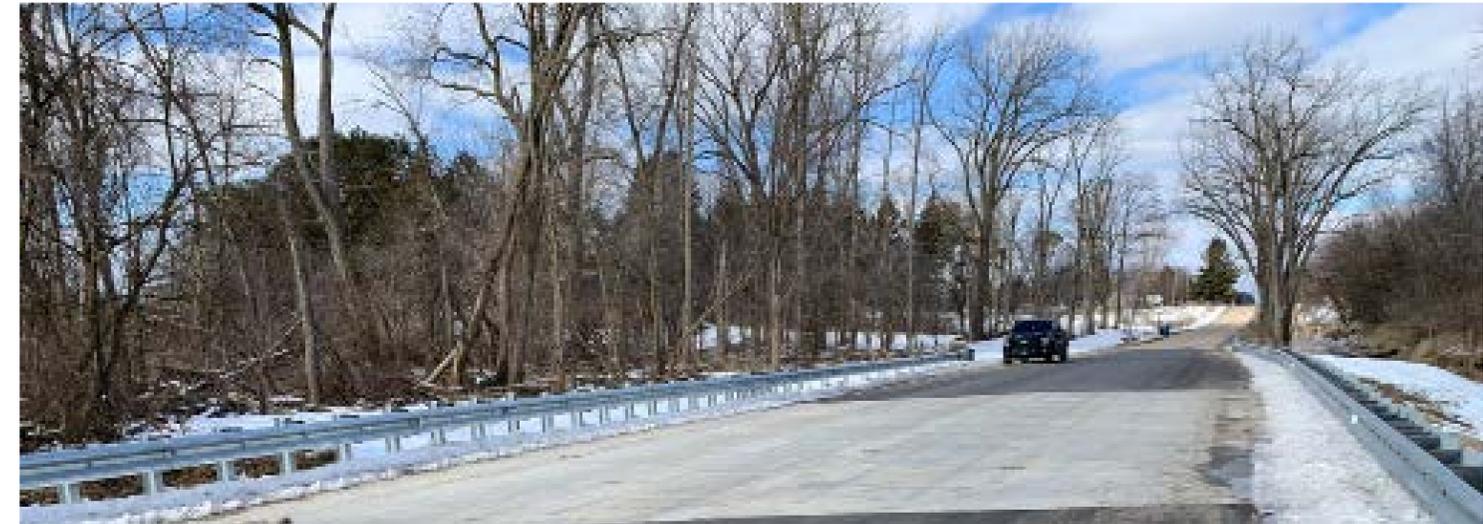
Completed Henry Road Bridge

By the middle of December, a bridge that had been closed for over 2 years was re-opened to traffic. Mercer County Bridge Division plans to place an epoxy overlay on the new precast concrete bridge deck to seal the joints and protect the new driving surface from chlorides.
